TOWN HALL

Town Hall: Property Conditions Assessment Report

Issued Monday 15 June 2020

Project Number: 202547

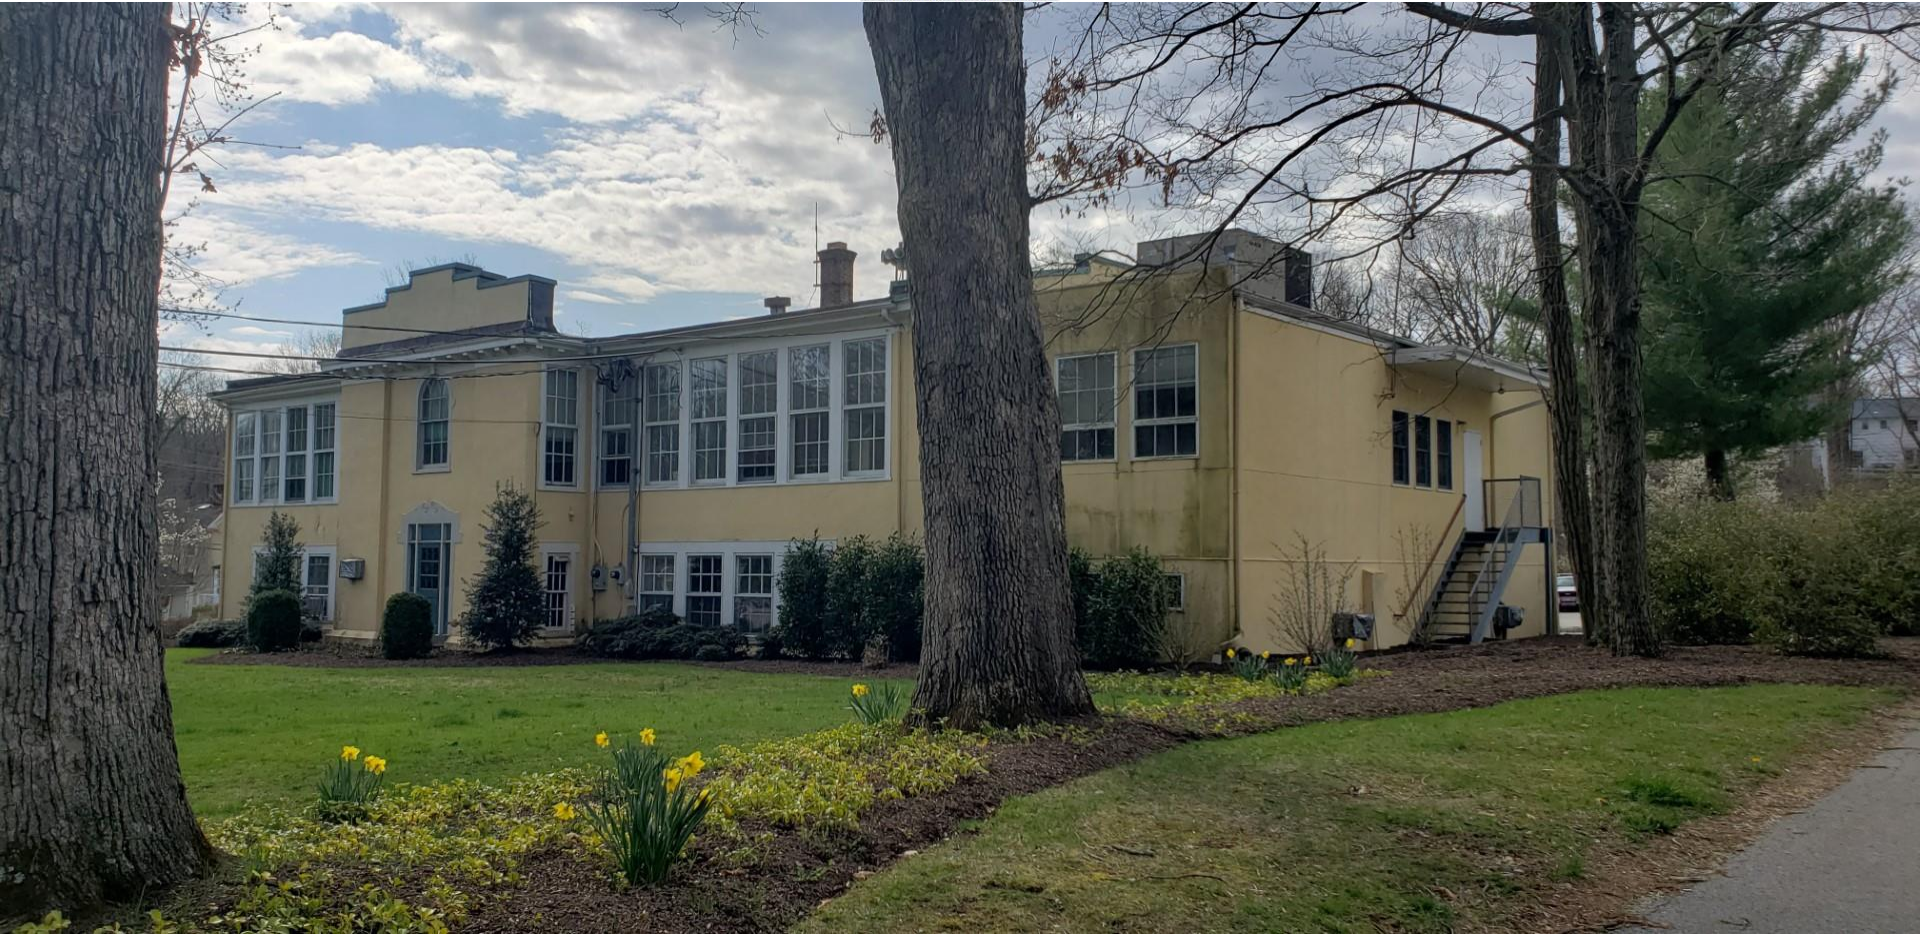
NORTH ELEVATION
EXISTING CONDITIONS – TOWN HALL – 2 WEST MAIN STREET

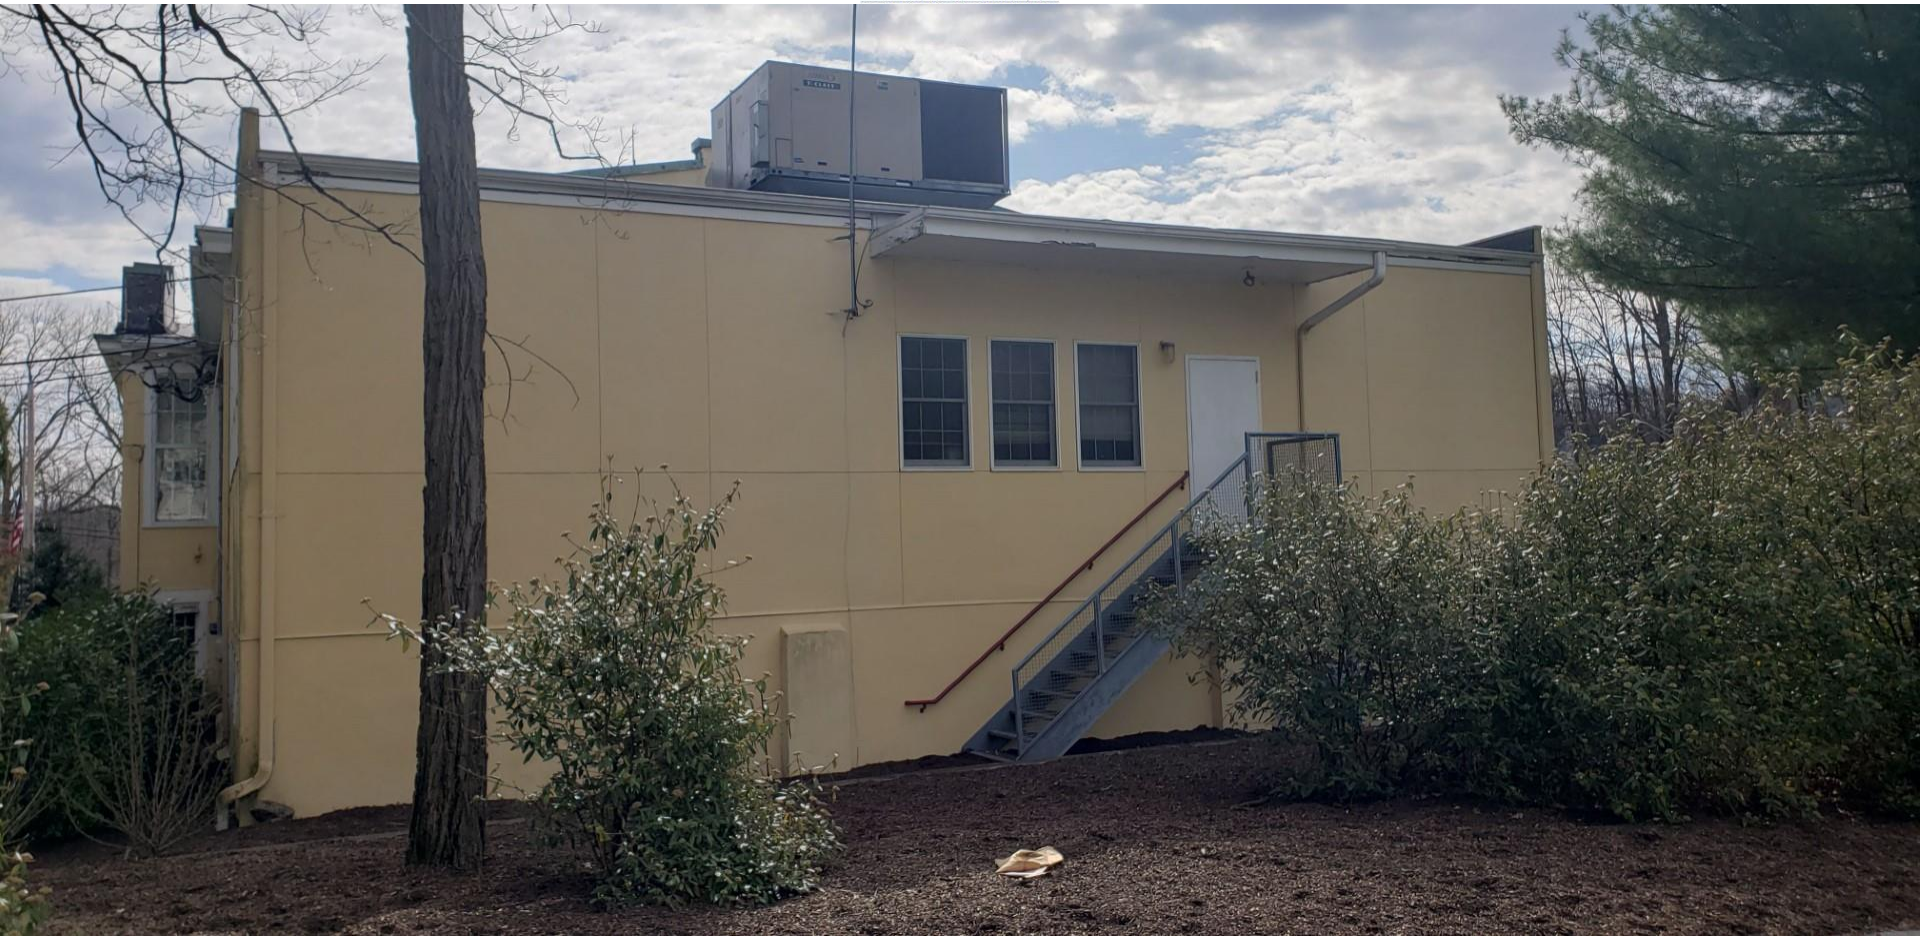
WEST ELEVATION
EXISTING CONDITIONS – TOWN HALL – 2 WEST MAIN STREET

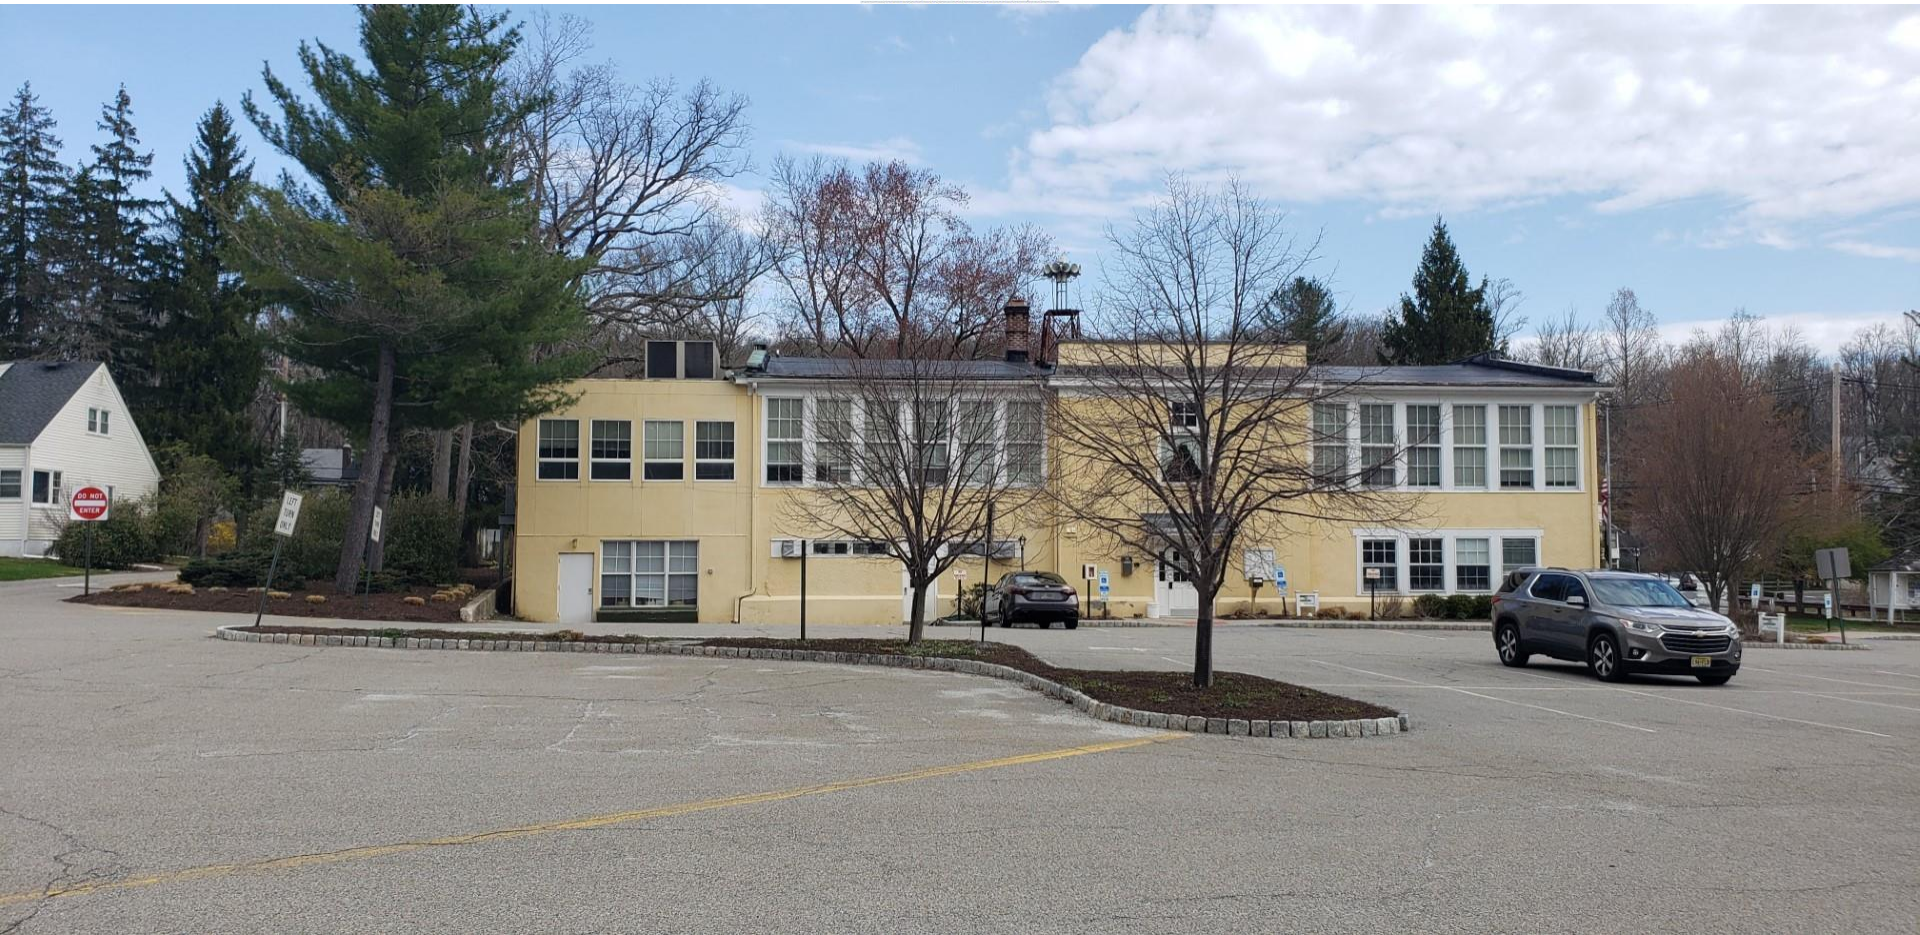
SOUTH ELEVATION
EXISTING CONDITIONS – TOWN HALL – 2 WEST MAIN STREET

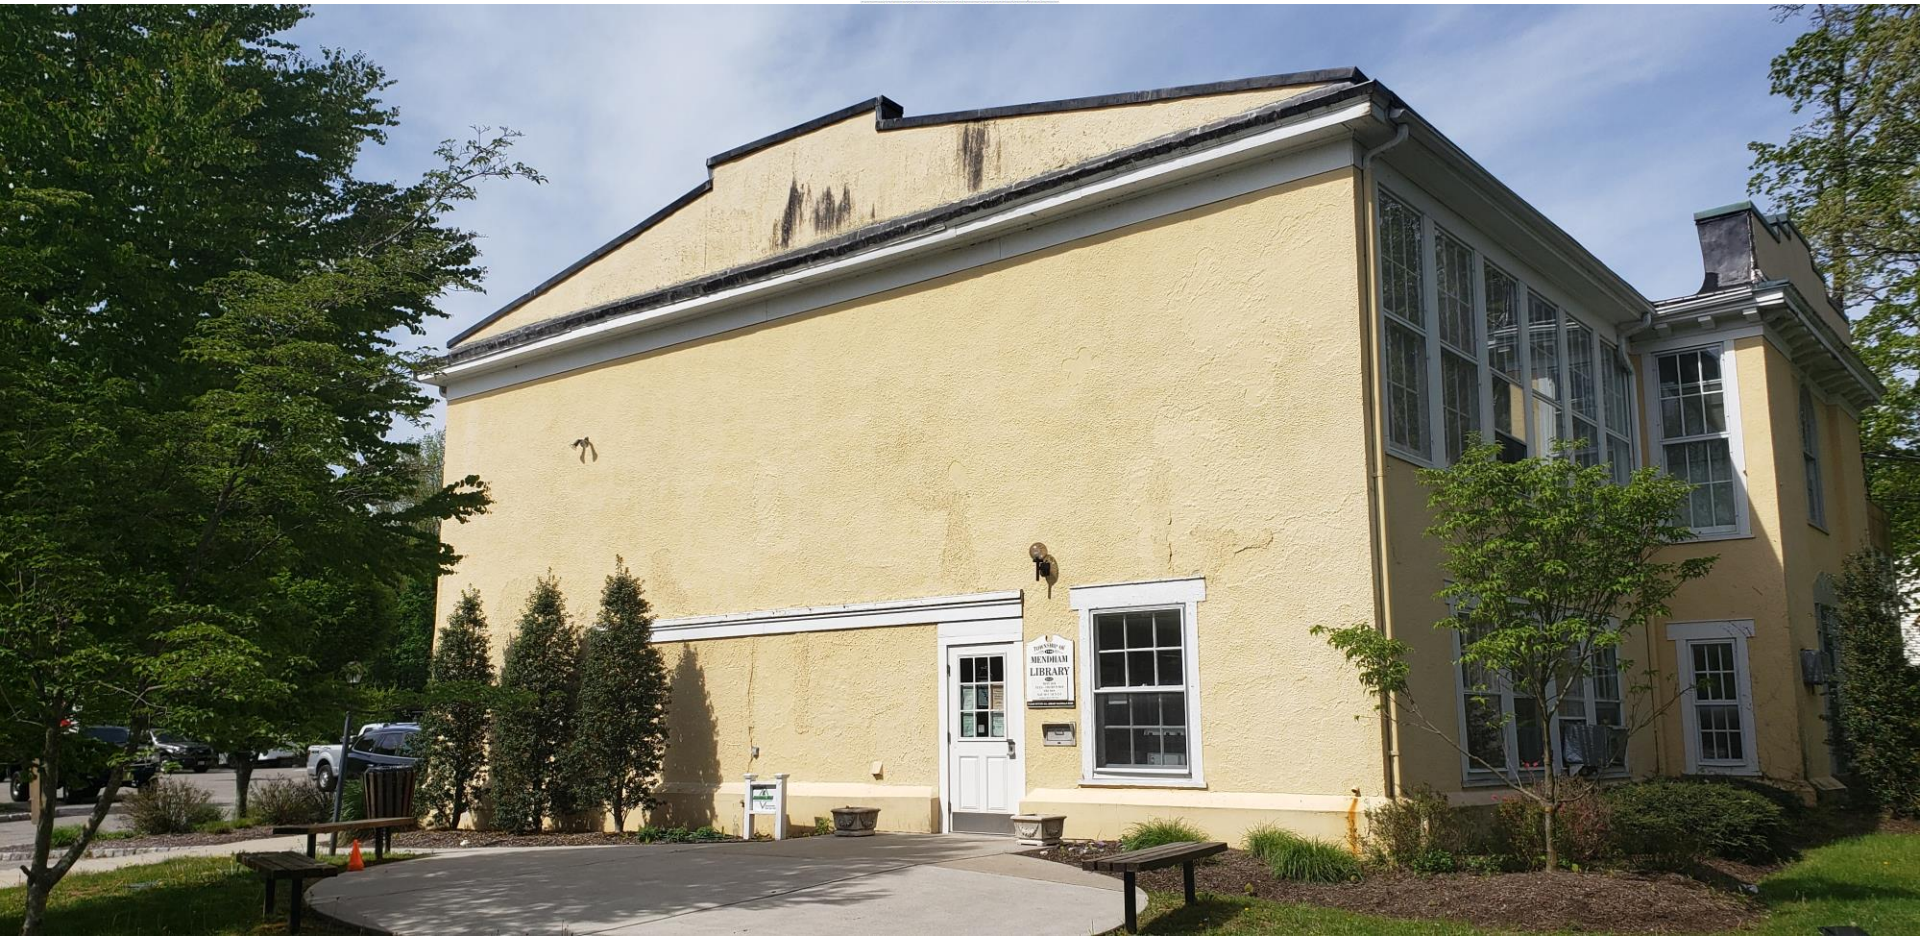
EAST ELEVATION
EXISTING CONDITIONS – TOWN HALL – 2 WEST MAIN STREET

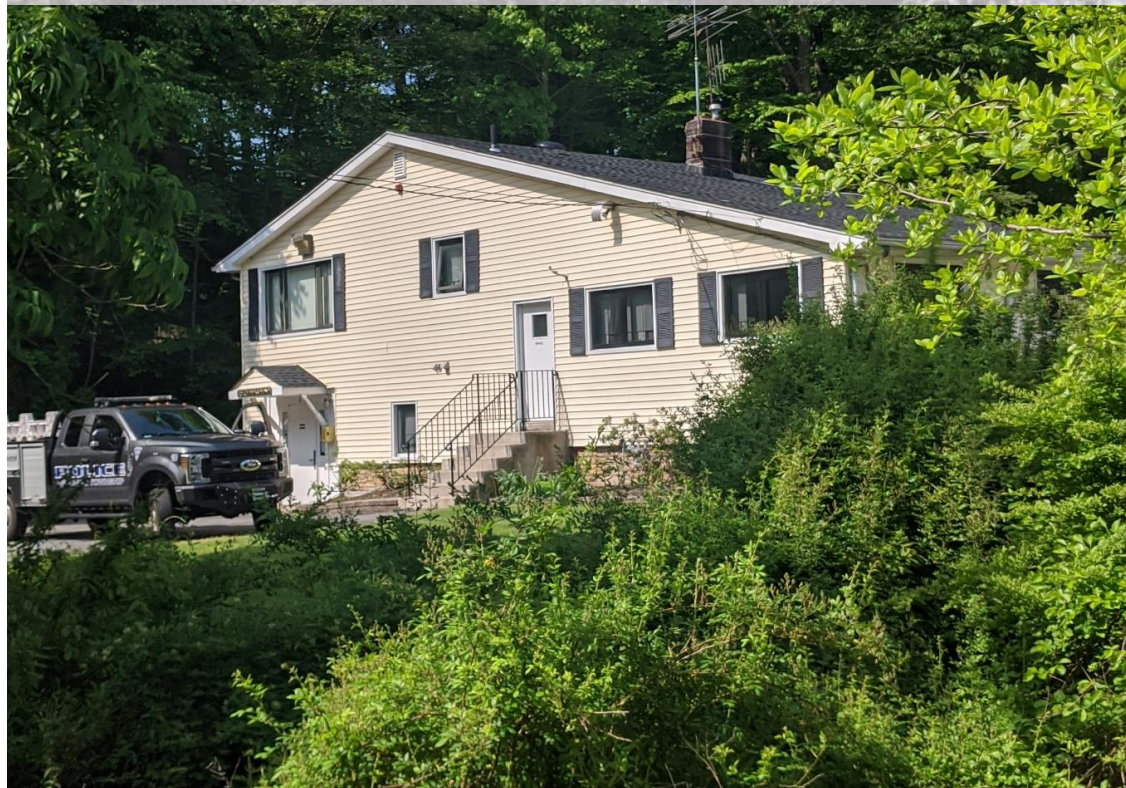
THE POLICE ARE NOT FUNCTIONING PROPERLY OR EFFICIENTLY IN THE CURRENT SPACE

LOCATED IN A FLOOD PLAIN – THE BASEMENT EVIDENCE ROOM AND FIRST FLOOR
RECEPTION AREA HAVE TAKEN ON WATER

THE BUILDING IS A 1960's SPLIT LEVEL – SMALL SPACES, SEPARATED BY STAIRS,
NARROW CIRCULATION, AND RIDDLED WITH INEFFICIENCY

SPACE IS OUTGROWN – EXPANDED INTO TRAILERS AND FIRE HOUSE

PERSONNEL ARE IN TIGHT QUARTERS AND SHARE PERSONAL SPACE
