Project Number 202547

Town Hall: Final Report

Town Hall: Property Conditions Assessment Report

Issued Monday 15 June 2020

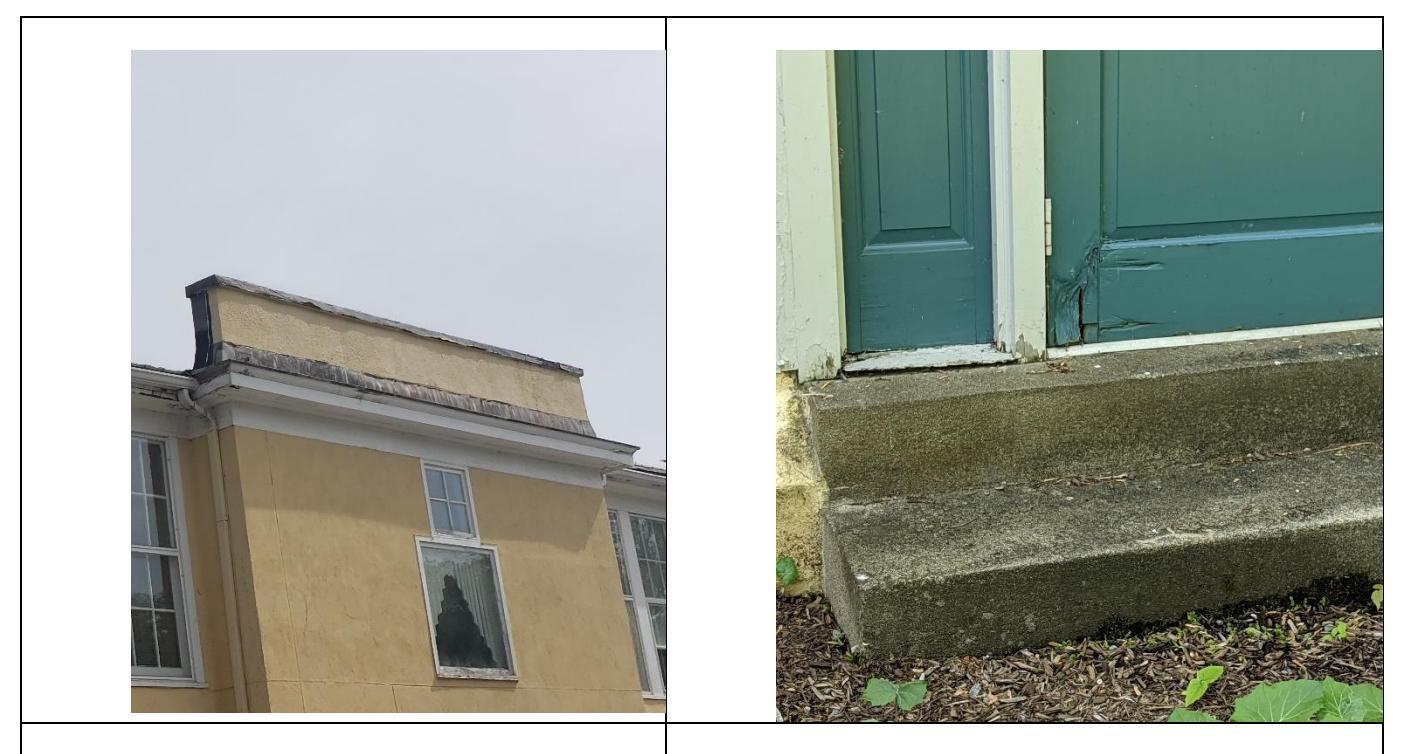
74. Water Damage at North Façade – Entry Door

Water damage was observed at the formal entry way on the North Façade (Photo 74). Damaged wood trim, window casings, and dentil molding (Photo 75-78) should be removed back to sound material and flashing installed to prevent water infiltration.

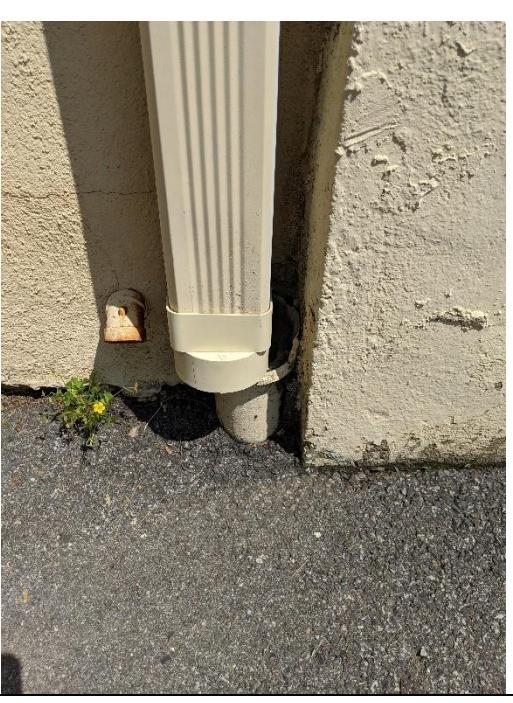
79. Cracked Storm Pipe

A cracked cast iron storm pipe was observed at the South façade (parking lot side) at the juncture of the original building and the new addition (Photo 79). The pipe should be replaced to prevent accumulation of water, freeze/thaw cycles, and further deterioration or water infiltration.

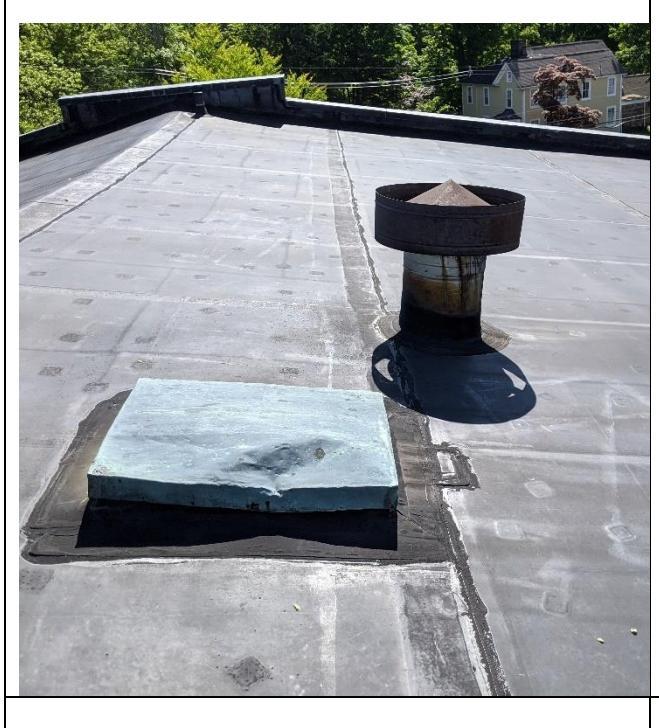
97. Roof – Damaged Scuttle Hatch

The condition of the membrane varies across the roof, ranging from fair to poor (Photo 93-99). Large tears were observed in the membrane allowing water infiltration. The substrate material felt soft underfoot indicating a deterioration of structural integrity. Areas of patching were observed, some of which were lifting away from the underlayer. Pitch pockets were pulling back, seams were splitting, and copper flashing was in poor condition.
