Environmental Impact Statement
For
Preliminary Minor Subdivision

Forrest View Estate

239 Mountainside Road

Township of Mendham

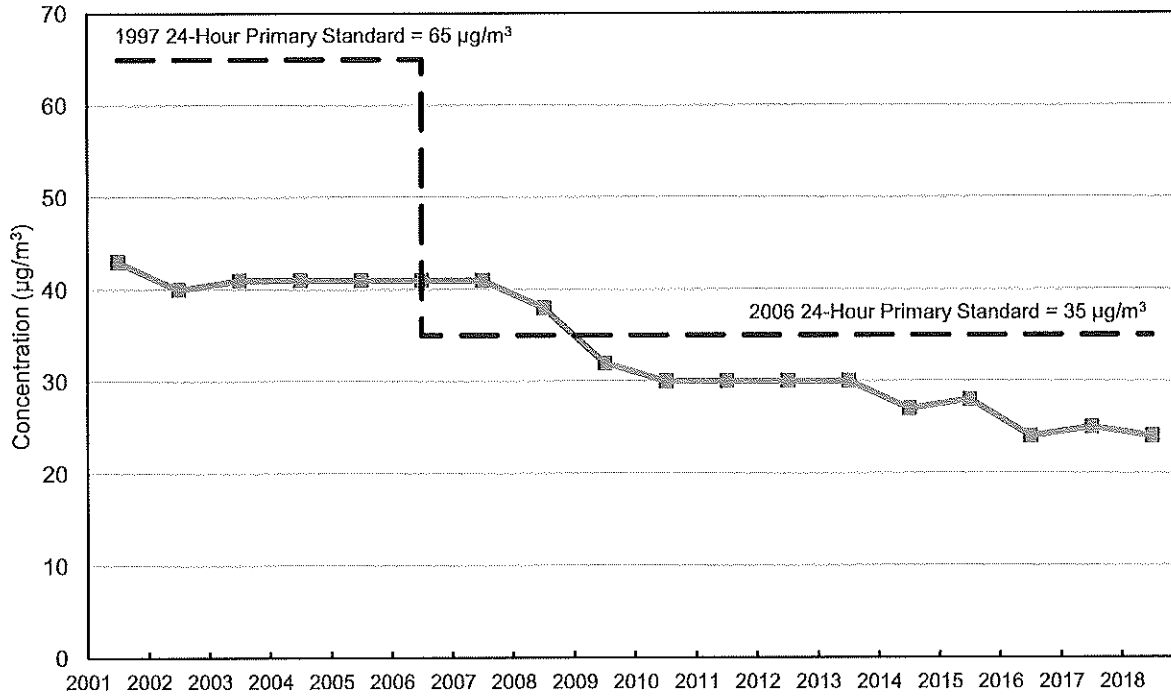
Figure 1-2
Fine Particulate (PM_{2.5}) 24-Hour Design Value Trend in New Jersey, 2001-2018
3-Year Average of the 98th-Percentile 24-Hour Average Concentrations
Micrograms per Cubic Meter (µg/m³)

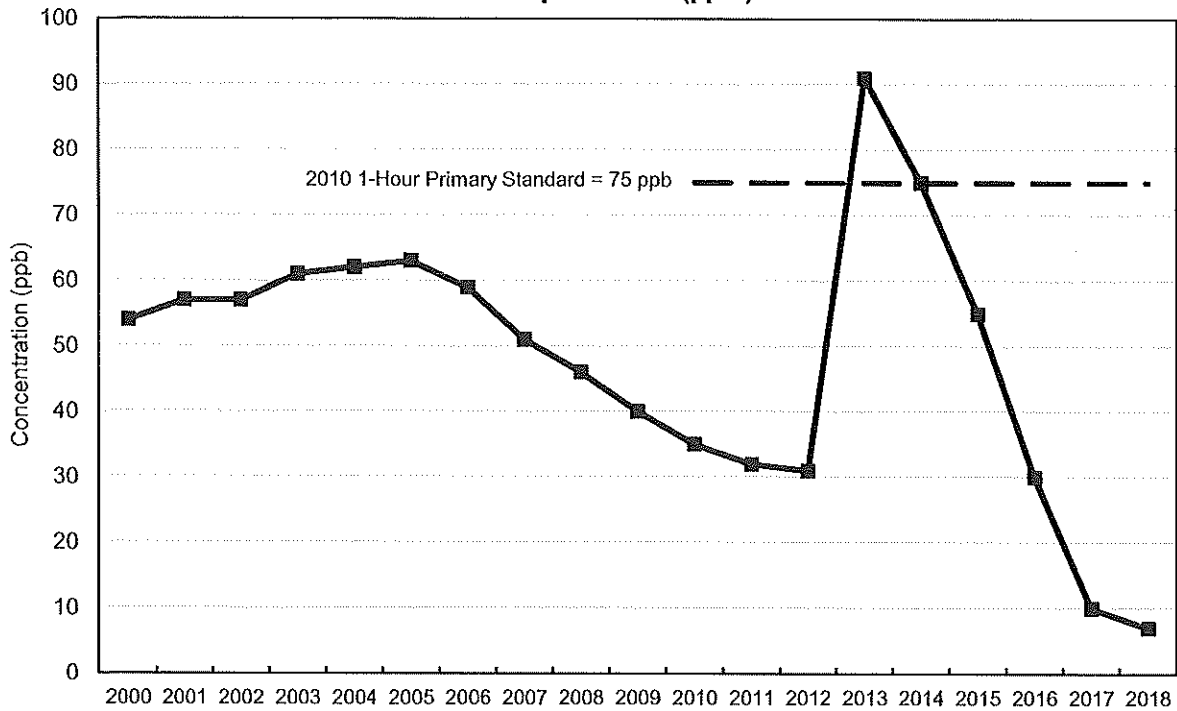
Figure 1-4
Sulfur Dioxide (SO₂) Design Value* Trend in New Jersey, 2000-2018
***3-Year Average of the 99th-Percentile of Daily Maximum 1-Hour Average Concentrations**
in Parts per Million (ppm)

The sharp increase and subsequent decrease in sulfur dioxide (SO₂) concentrations in New Jersey shown in Figure 1-4 are attributable to a coal-burning facility across the Delaware River in Pennsylvania. NJDEP established the Columbia monitoring station in 2010 to determine the facility's impact on New Jersey's air quality. Exceedances of the SO₂ NAAQS were recorded that same year. Since the plant ceased operations under a court agreement, SO₂ levels in New Jersey have again been meeting the standard.

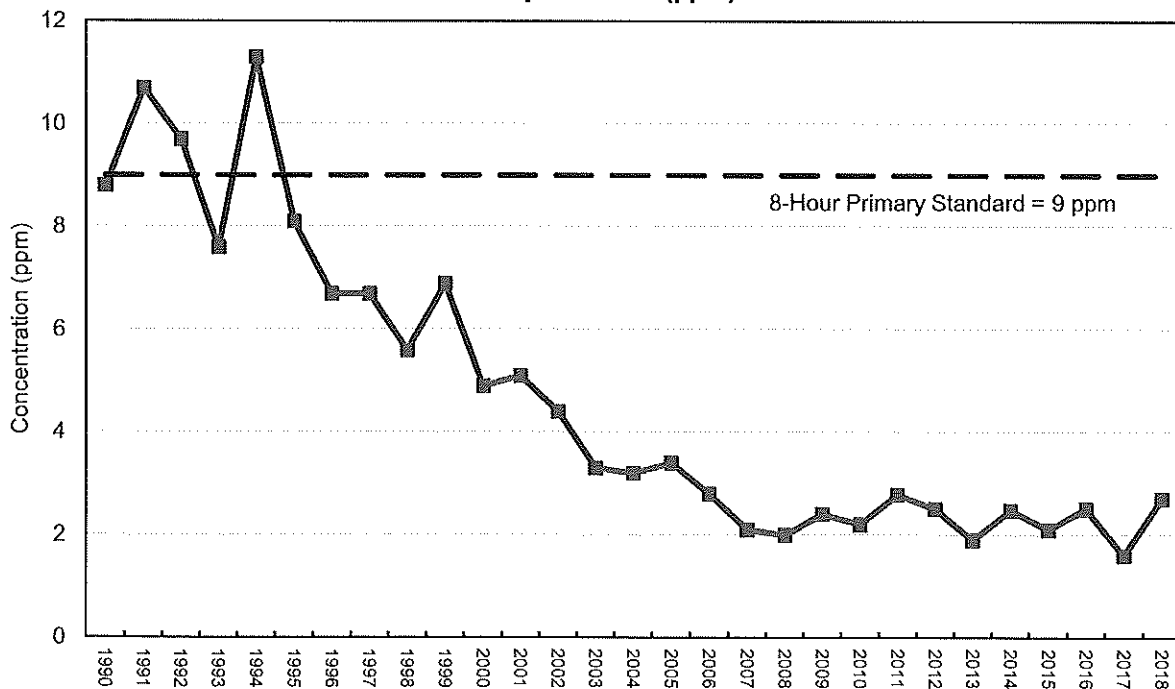
Figure 1-5
Carbon Monoxide (CO) Design Value Trend in New Jersey, 1990-2018
2nd-Highest 8-Hour Average Concentration
Parts per Million (ppm)

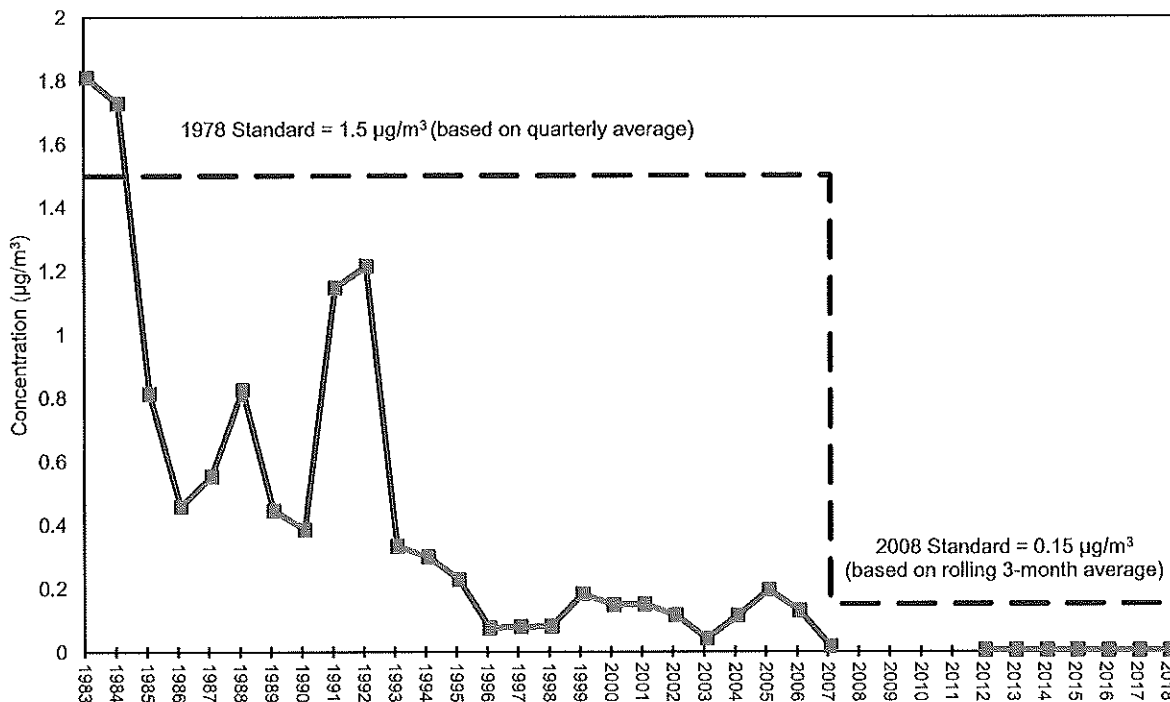
Figure 1-6
Lead Design Value Trend in New Jersey, 1983-2018
Highest 3-Month Average
Micrograms per Cubic Meter ($\mu\text{g}/\text{m}^3$)

Air concentrations of lead have dropped dramatically since a standard was established in 1978. The last exceedances of the NAAQS were in the early 1980s (Figure 1-6).
