Project Number 202547

Town Hall: Final Report

Town Hall: Property Conditions Assessment Report

Issued Monday 15 June 2020

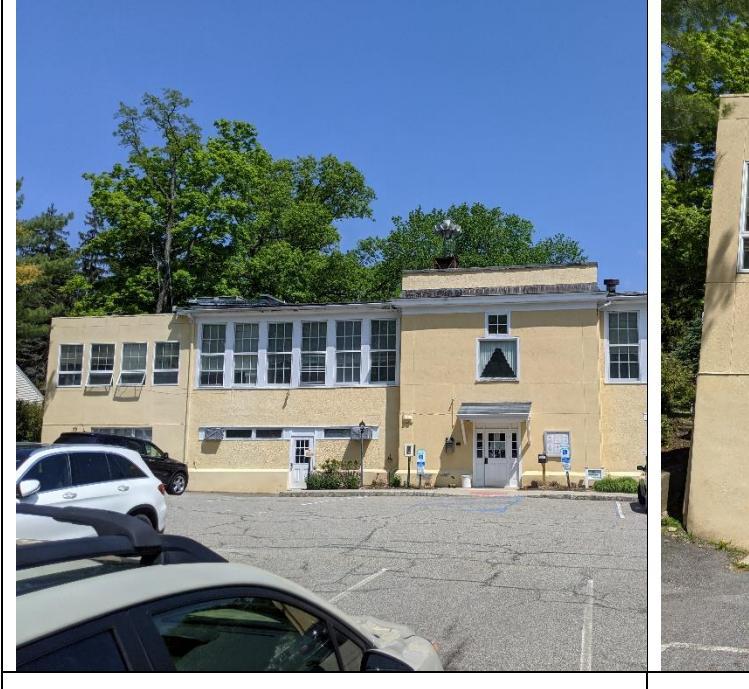
46. Addition – North Elevation

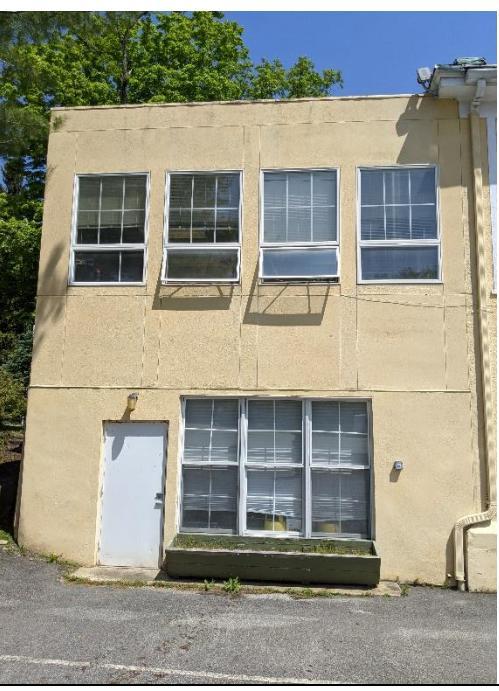
47. Addition – South Elevation

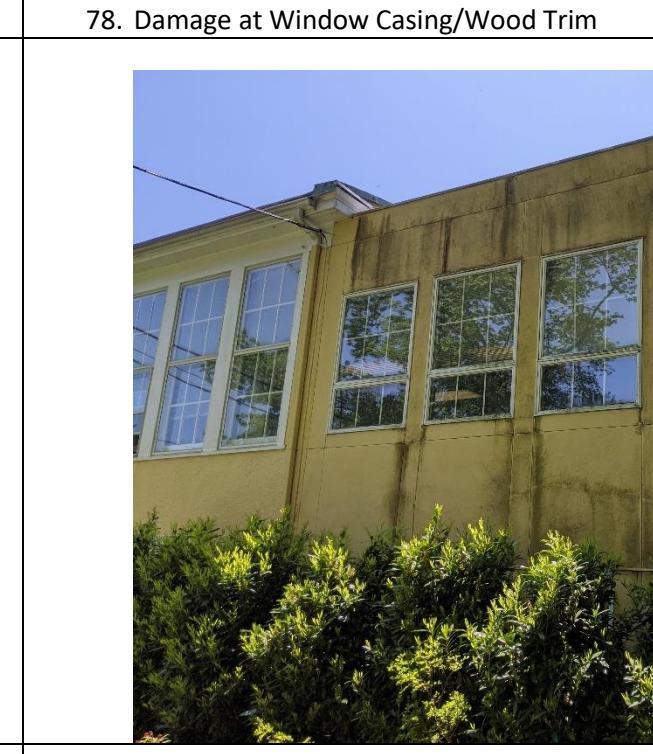
77. Damage at Window Casing/Wood Trim

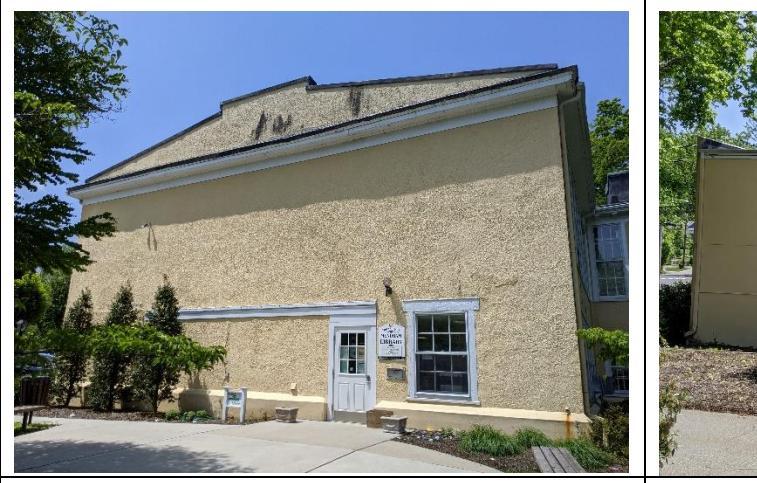
88. South Elevation

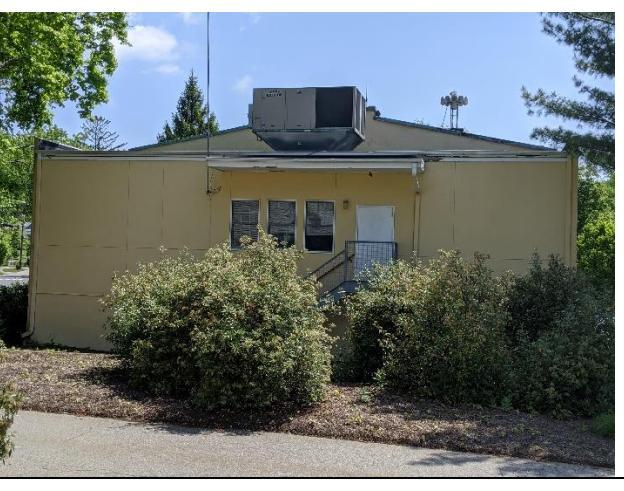
89. East Elevation

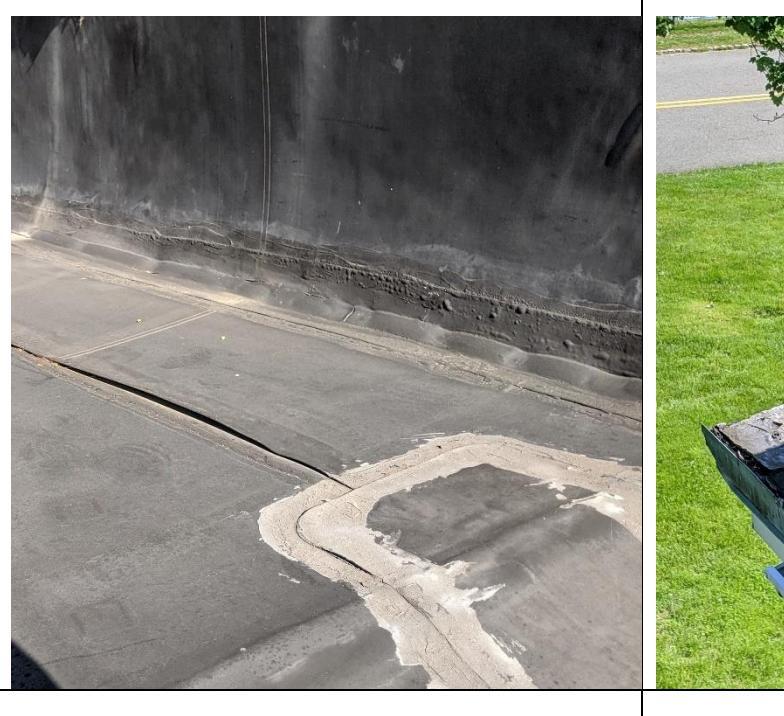
92. Roof Membrane and Parapet

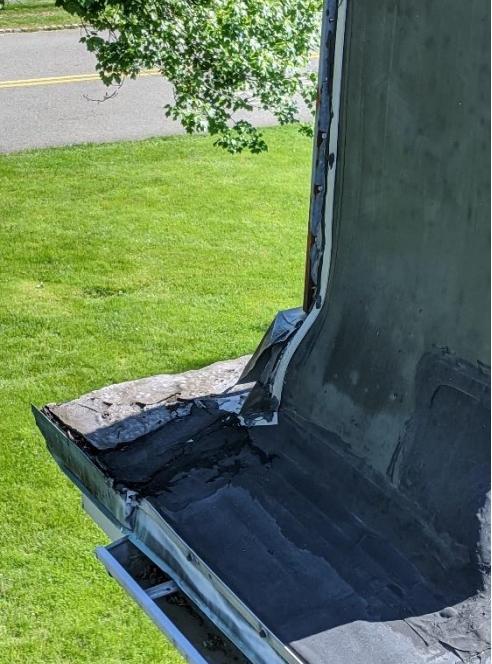
93. Roof – Membrane Peeling/Patching

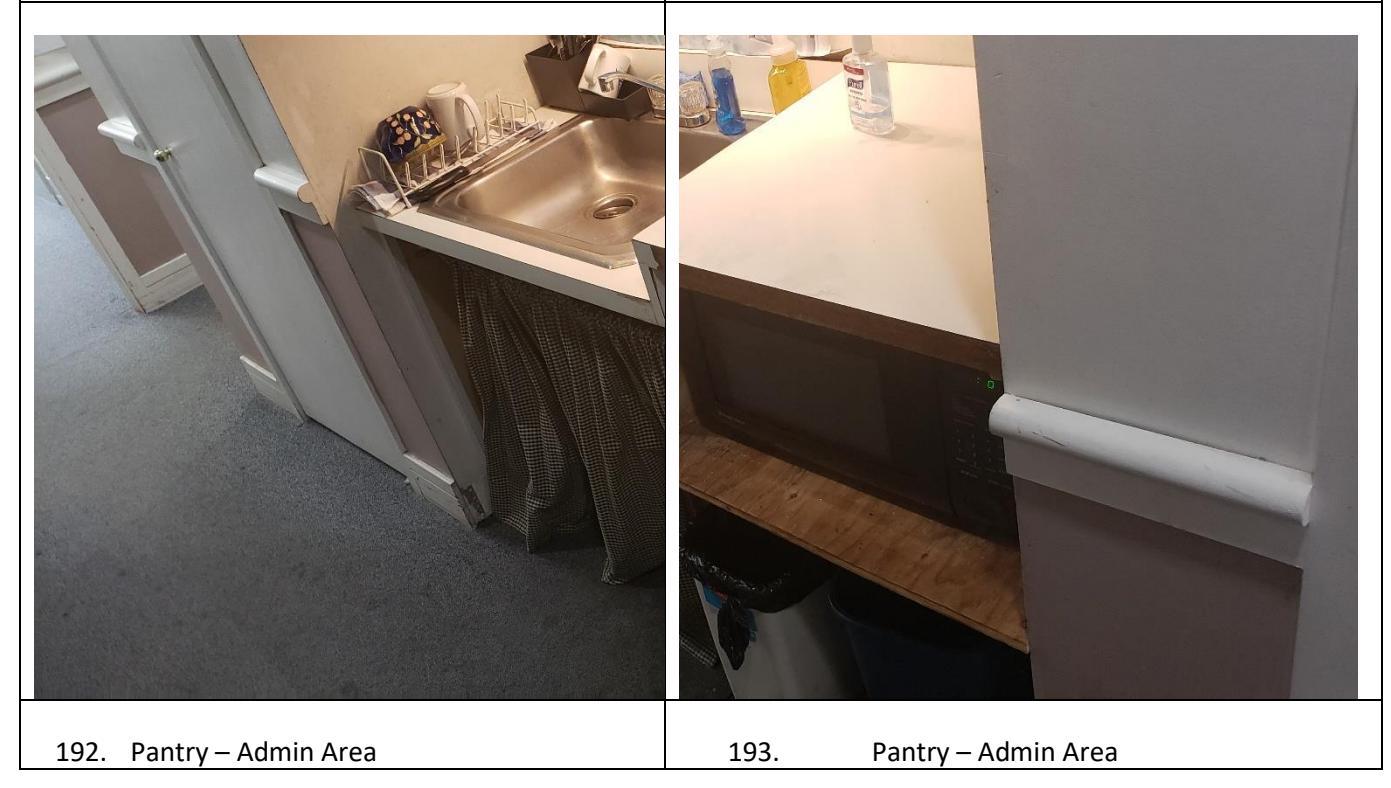
190. Pantry – Admin Area

191. Pantry – Admin Area

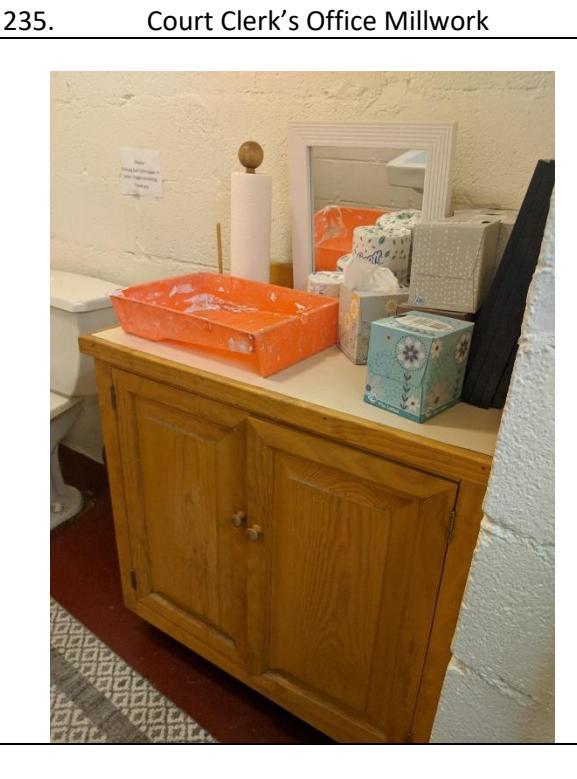
234. Millwork Dais at Municipal Court Room

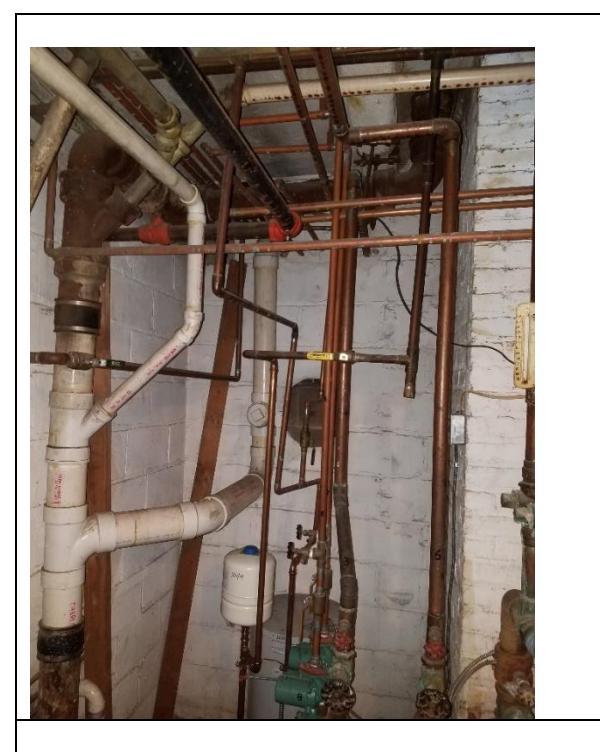
258. Various Sanitary Piping

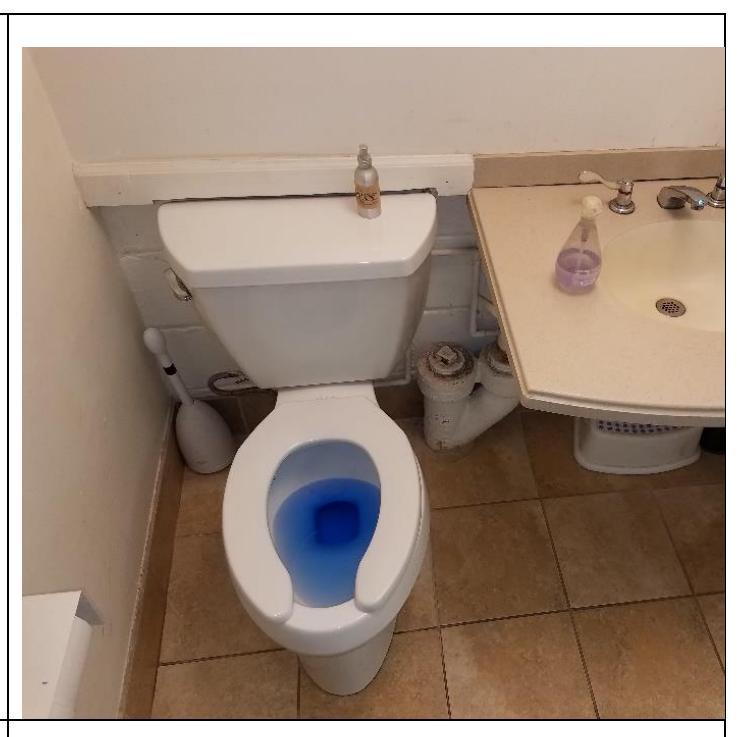
259. Library Toilet Room Fixtures

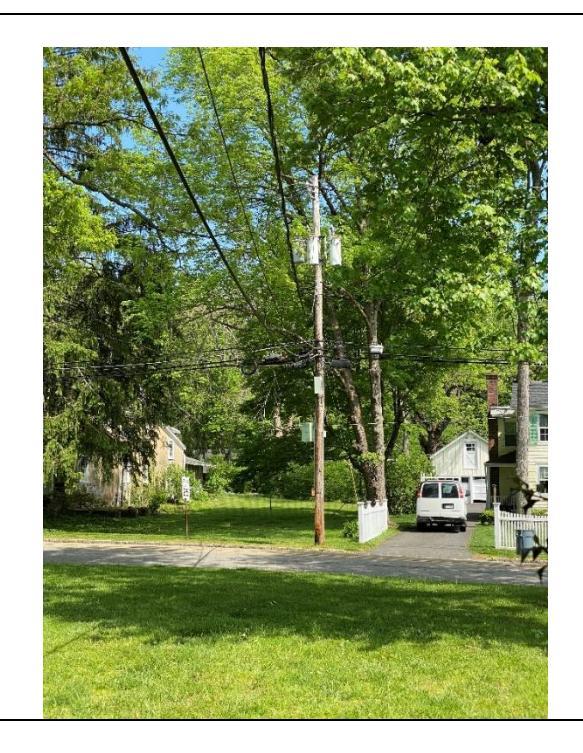
270. Electrial Service Transformers

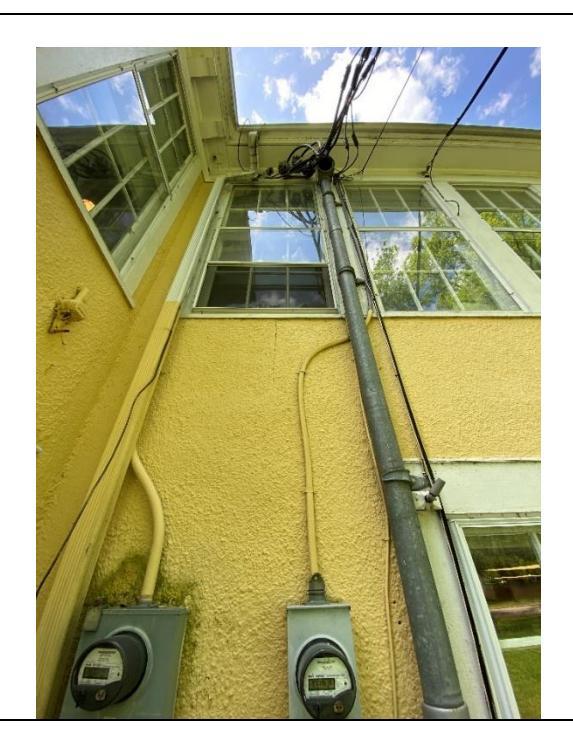
271. Weatherheads and Electric Meters

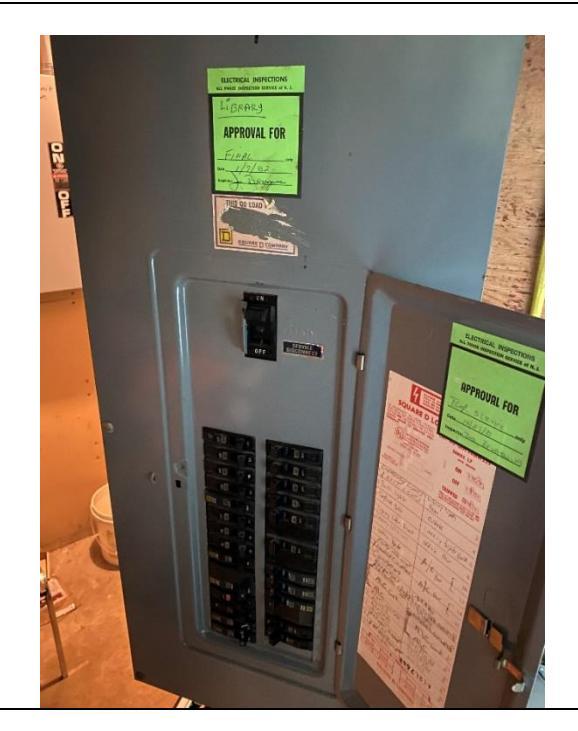
272. Library Panelboard

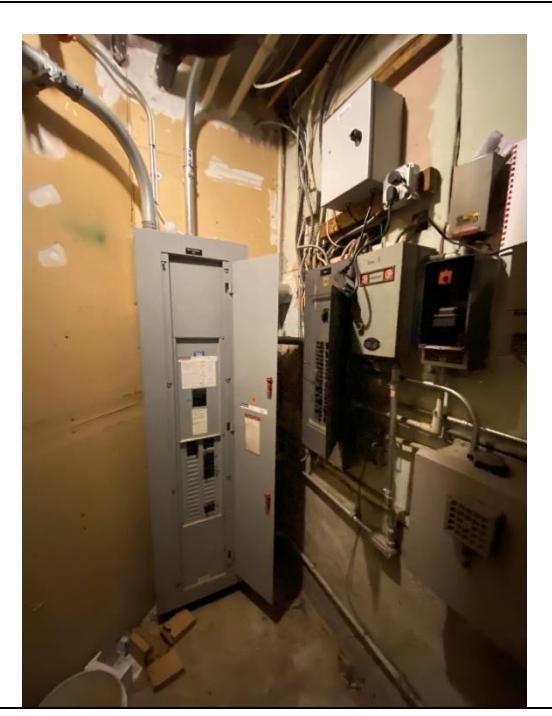
273. Town Hall Building MDP

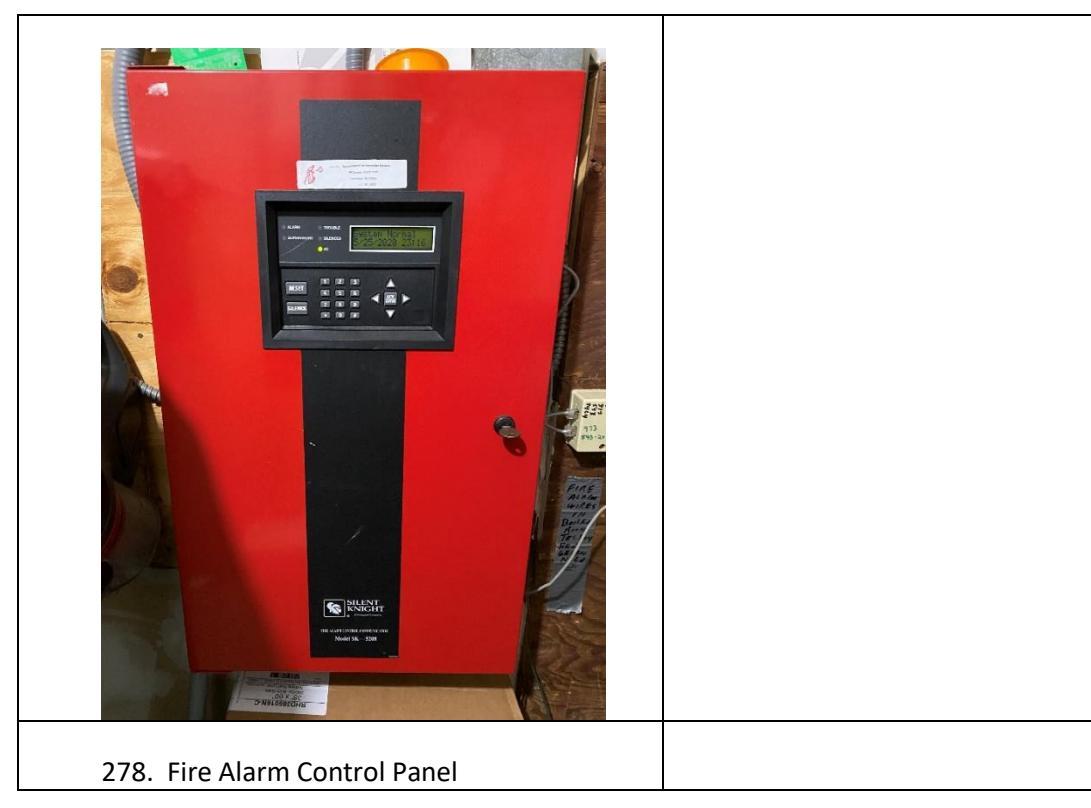
276. Typical Lighting in Library

277. Municipal Court Lighting
